**Conservation Engineering Survey and Assessment Report**

**Spirit of Newfoundland (Masonic Temple),  
Cathedral Street,  
St. Johns,  
Newfoundland.**

**Date:** 3<sup>rd</sup> July 2018

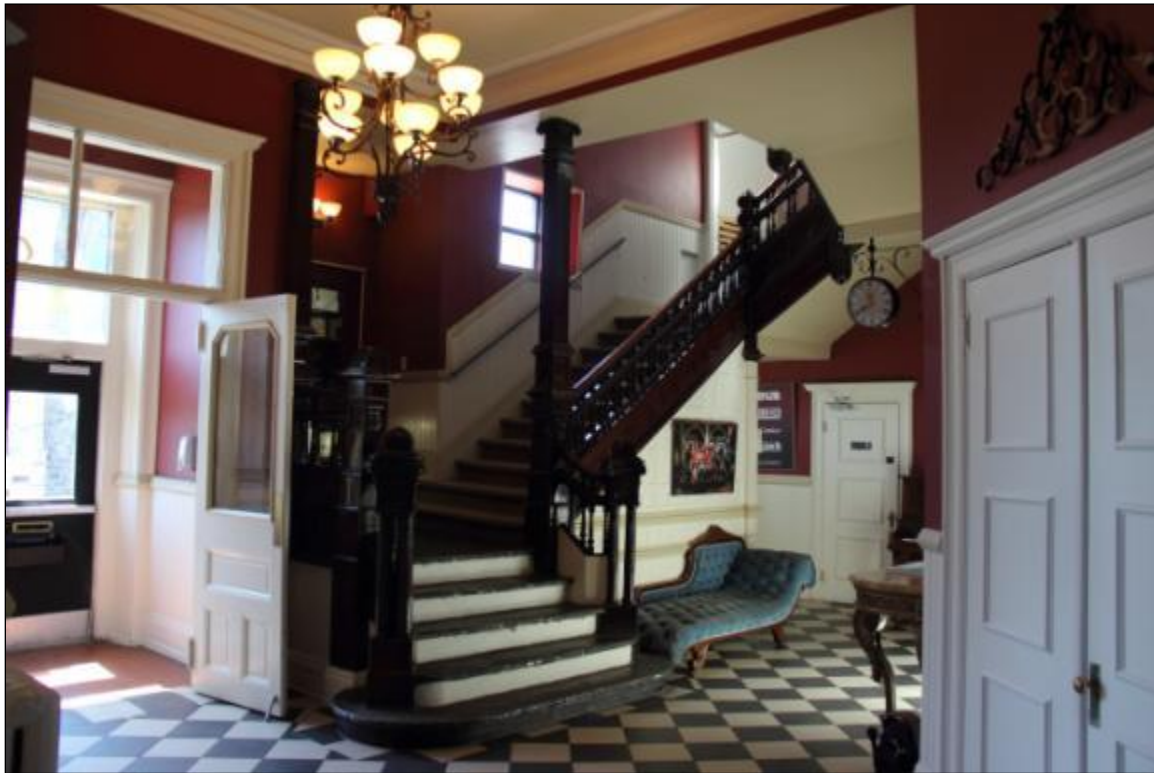
**Photo 1 - Ground Floor Lobby and Staircase**

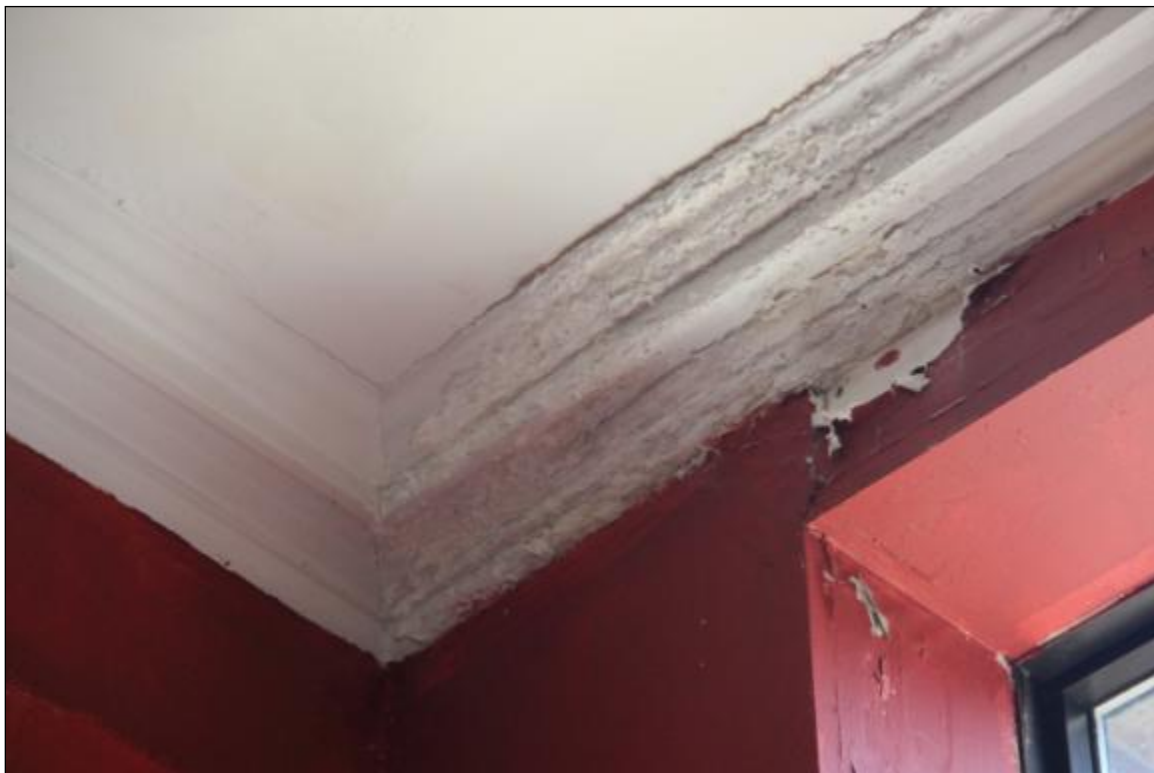
**Photo 2 - Moisture Damage above stairs landing**

<b>Works Required:</b>  <b>Desirable work</b> - is what is recommended to enhance the use or appearance of the building or what is necessary for re-evaluation or adaptive use of the building.  Recommended works to the ground floor are generally considered to be desirable in nature and will form a large part of the general maintenance and “good housekeeping” programme of a building of this age and construction type.  The localised area of water ingress above the ground floor stair landing is to be considered as necessary repair works to be carried out in the near future along with the necessary and urgent external repairs required to the front facade of the building.

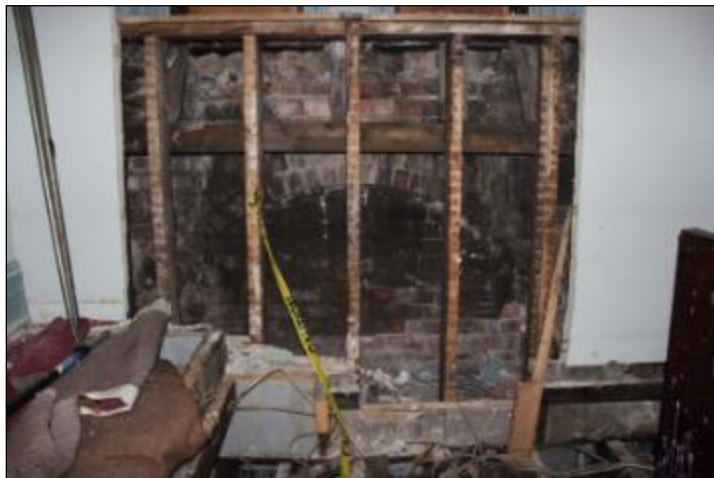
**Photo 3 - Previous opening up works below window in Blue room**

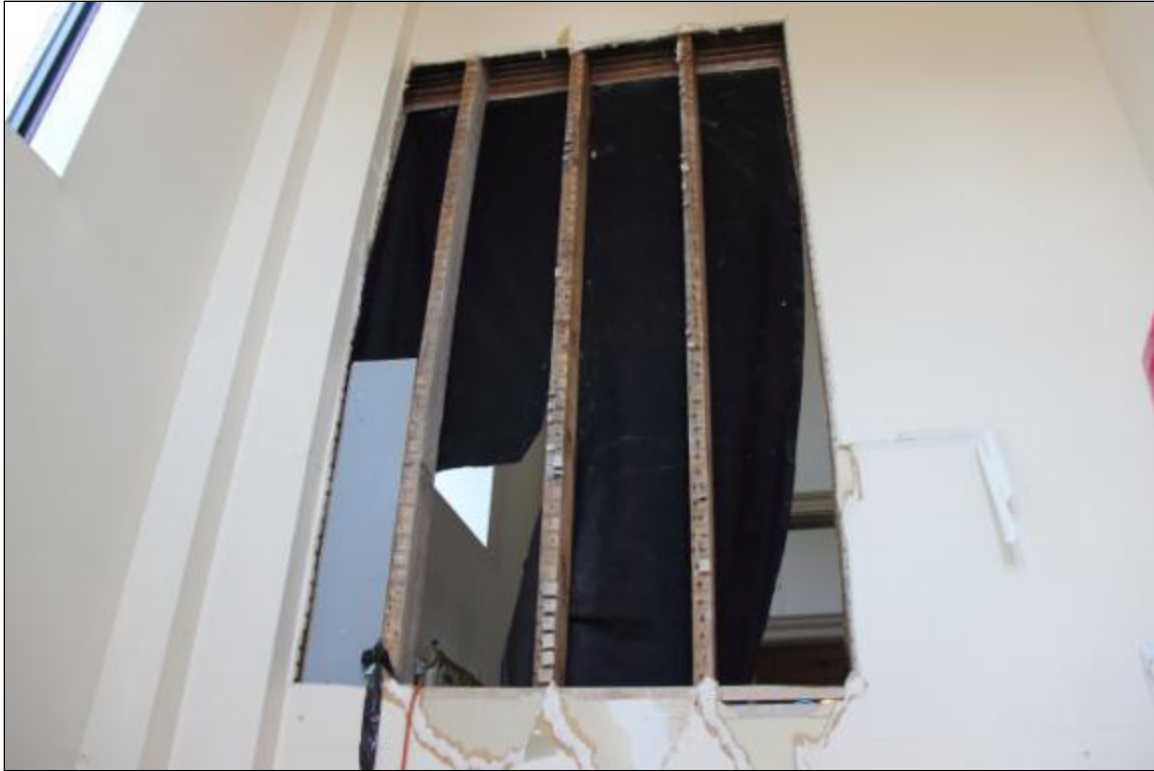
**Photo 5 - First Floor opening showing modern plasterboard over original lath and plaster**

- Clearing out of the first floor to include the removal of unnecessary storage space to reduce load and make it easier for future inspections to the building fabric.
- Repair floor areas where original floorboards have been removed.
- Carry out repairs to the decorative ceiling in the Blue room to restore the original character of the curved ceiling.
- Removal of modern insulated plasterboard and replace with insulated lime based system.

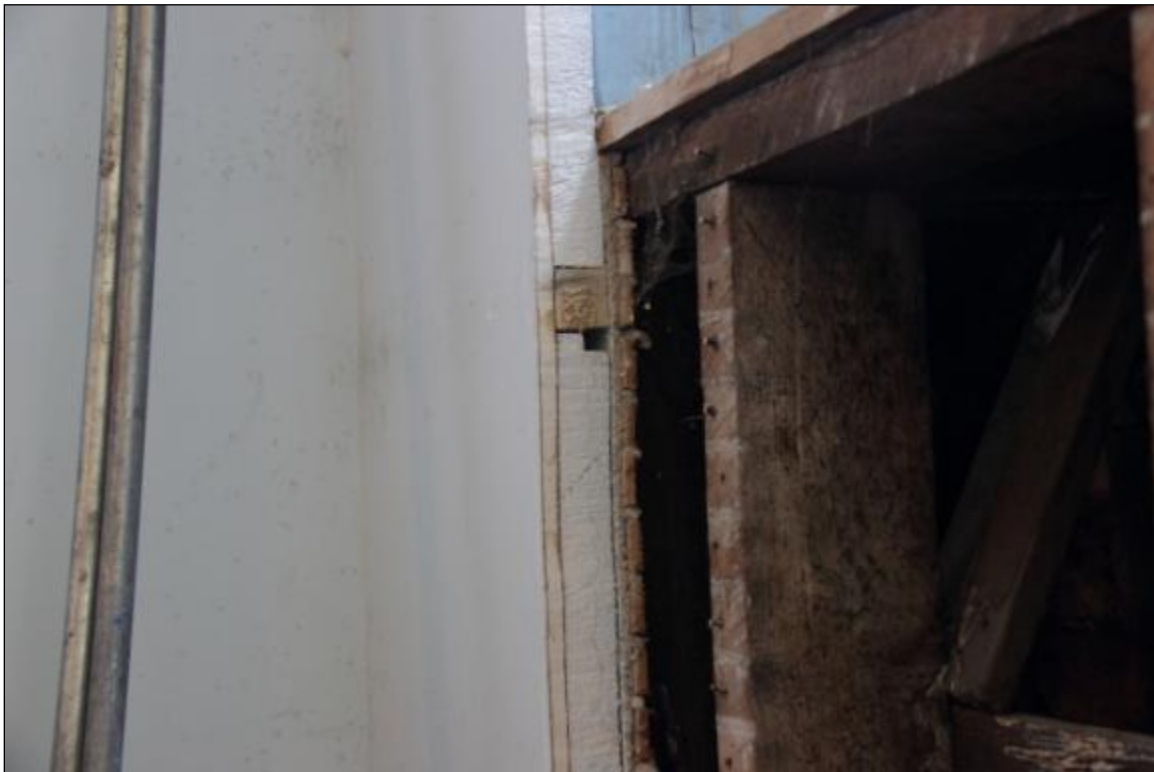
**Photo 6 - Insulated plasterboard fixed to original lath and plaster**

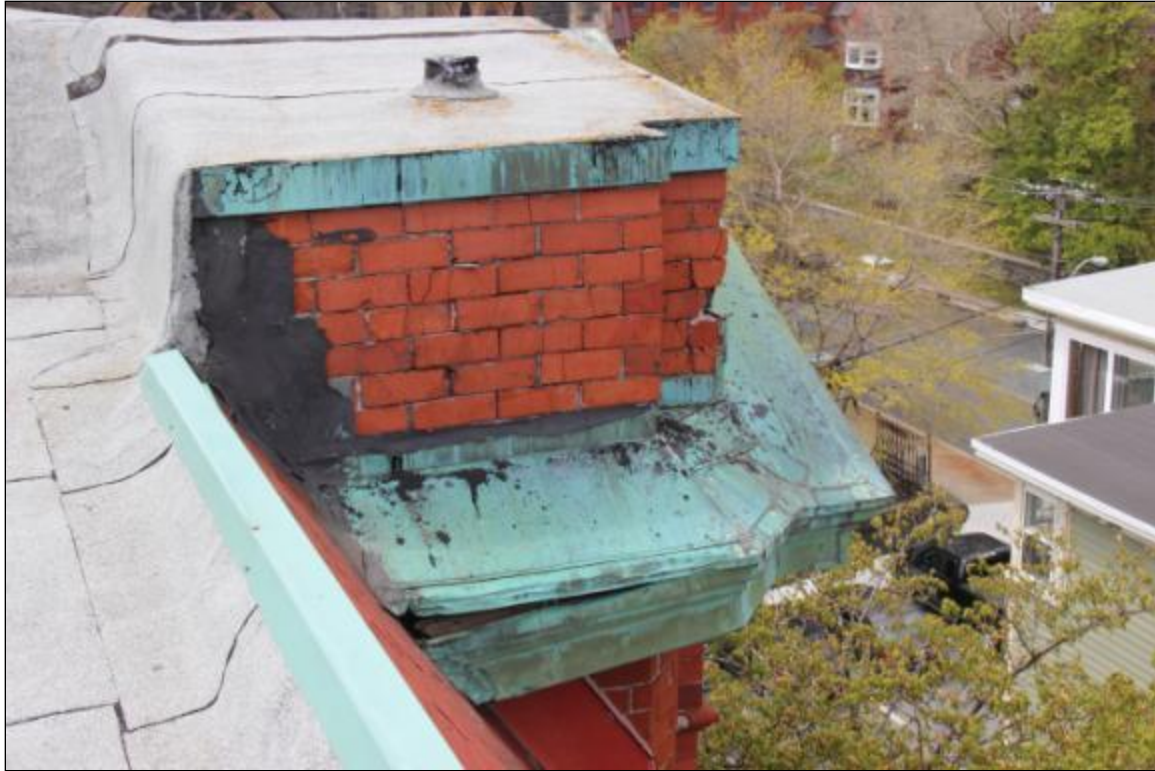
<p>The copper flashing to the 3 no. towers of the front facade are in very poor condition. There are many instances of cracked joints and poor repair techniques that are leading to significant water ingress to the walls at eave level. Previous patch repairs sealed with mastic have failed in many instances. A modern sheet metal flashing has been installed in parts covering the ridge of the hipped roof sections.</p>	
<p>The seal between the copper flashing and the modern felt roof covering is in very poor condition. The mastic sealant has failed in many areas and is allowing standing water on the seam and water ingress into the walls and roof structure.</p>	
<p>The use of inappropriate fixings and steel mesh to hold back the failing brickwork of the facades is leading to significant staining of the copper in some areas. This is leading to bi-metallic corrosion of the copper which is causing pitting to occur. In time these areas will lead to significant water ingress and complete failure of the copper flashings.</p>

**Photo 7 - Damaged copper work and inappropriate repairs to side of tower on the NW elevation**

- Repair works to the copper flashings and decorative details of the roof.
- Removal of previous poor repairs such as mastics, sealants and inappropriate fixings such as non-galvanised or non-stainless steel nails and screws.

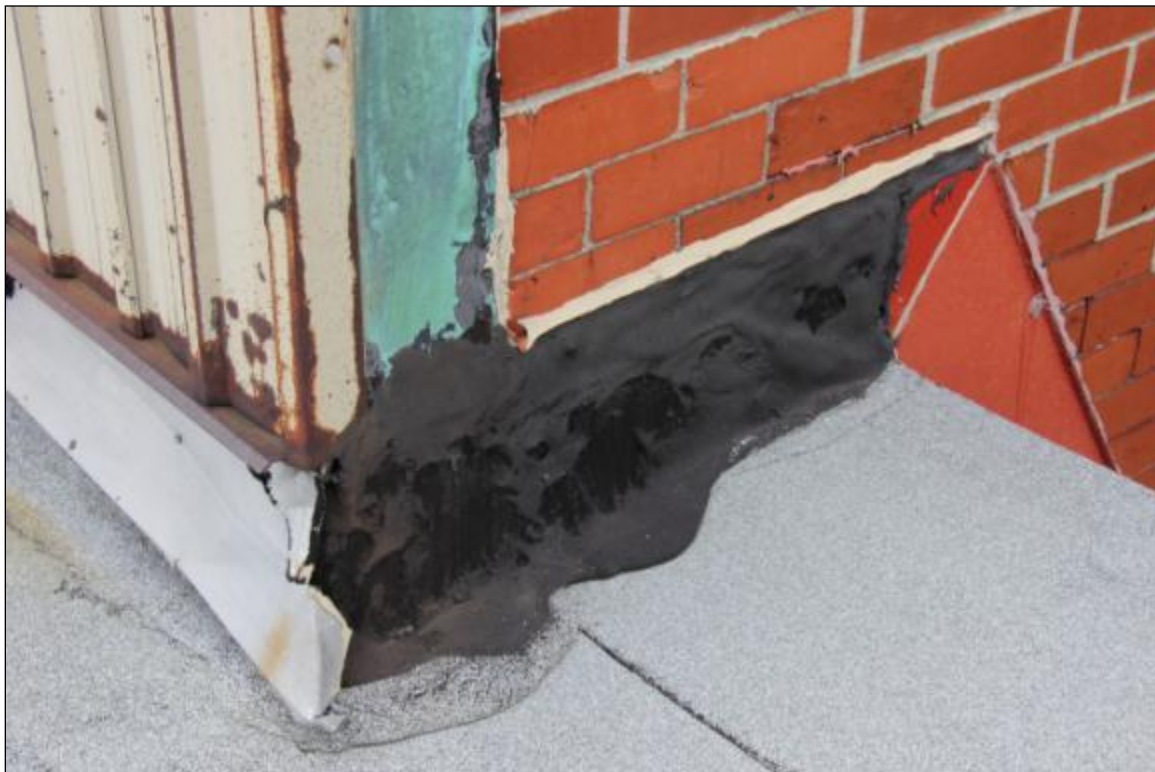
**Photo 8 - Inappropriate modern repairs to flashing on central tower of the front elevation.**

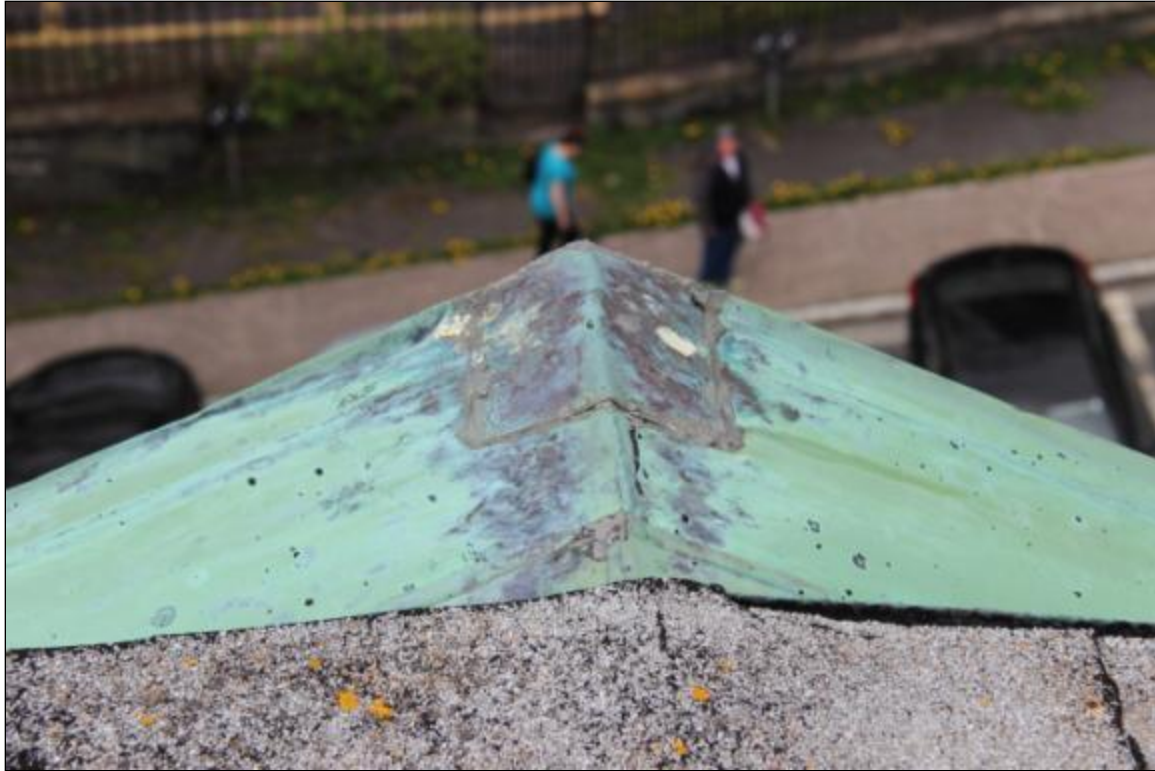
**Photo 9 - Failed copper patch repair to top of central tower**

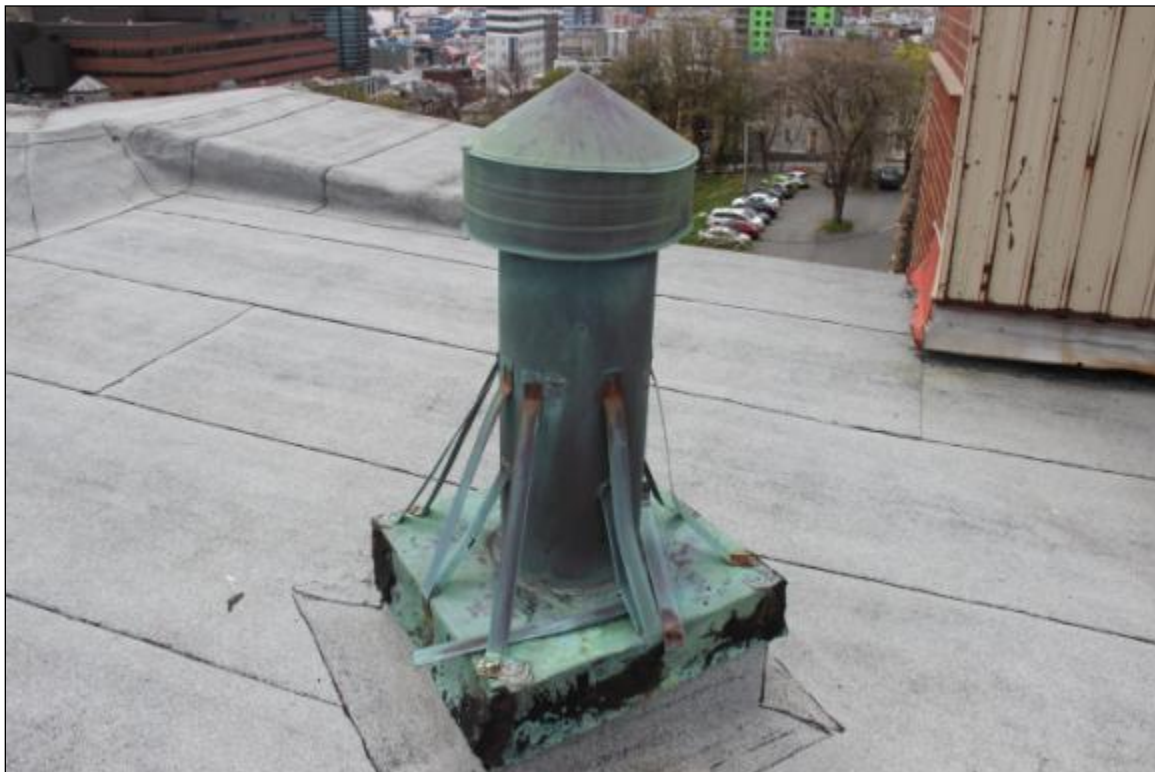
<p>The copper vents on the roof which form part of the buildings ventilation system are in very poor condition. The base of the vents appears to be made up of the original copper while the upright shafts have been replaced in recent times with new copper. The use of inappropriate fixings is leading to the failure of the supporting straps and bi-metallic corrosion of the copper as well as staining from steel nails.</p>	
<p>The central tower of the front elevation has been repaired in recent times with modern</p>

**Photo 10 - Copper ventilation shaft. Note staining due to use of steel fixings.**

- Removal of the steel mesh and fixings to the top of the front facades which are causing significant staining of the copper.
- Repair damaged fixings to the copper roof vents to match existing using appropriate materials such as copper nails and fixings.

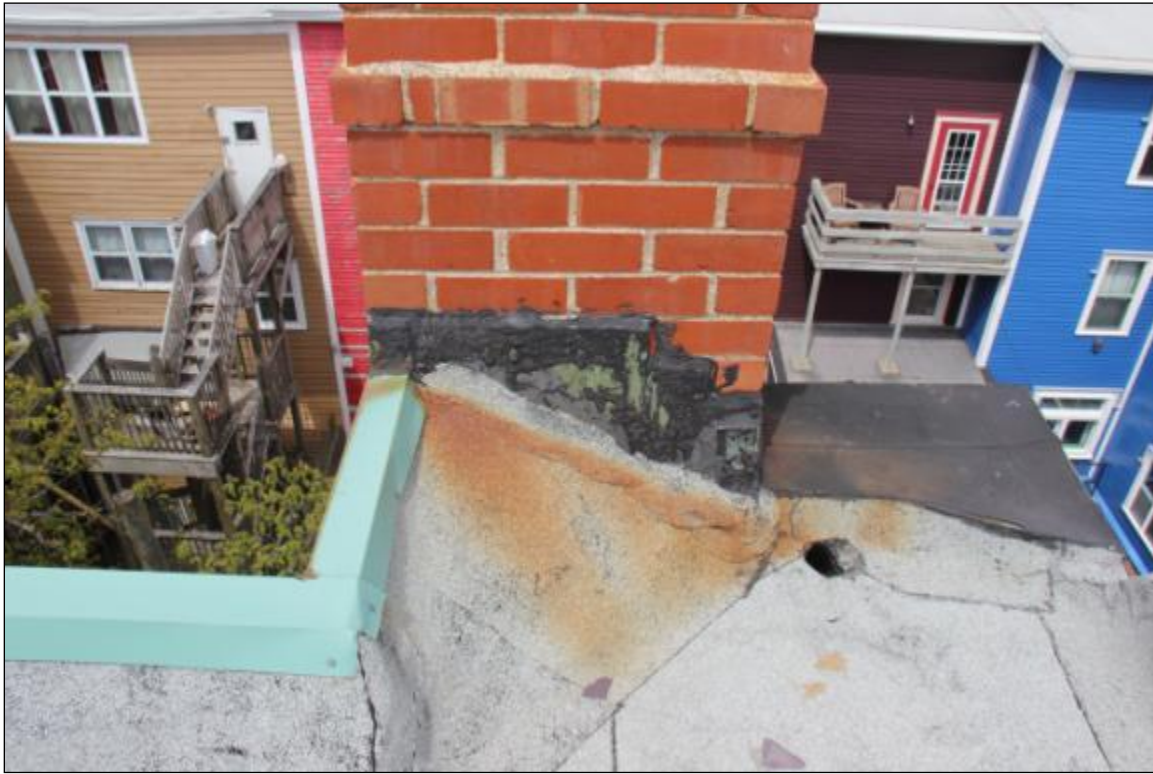
**Photo 11 - Base of chimney and rainwater gulley on Rear Elevation**

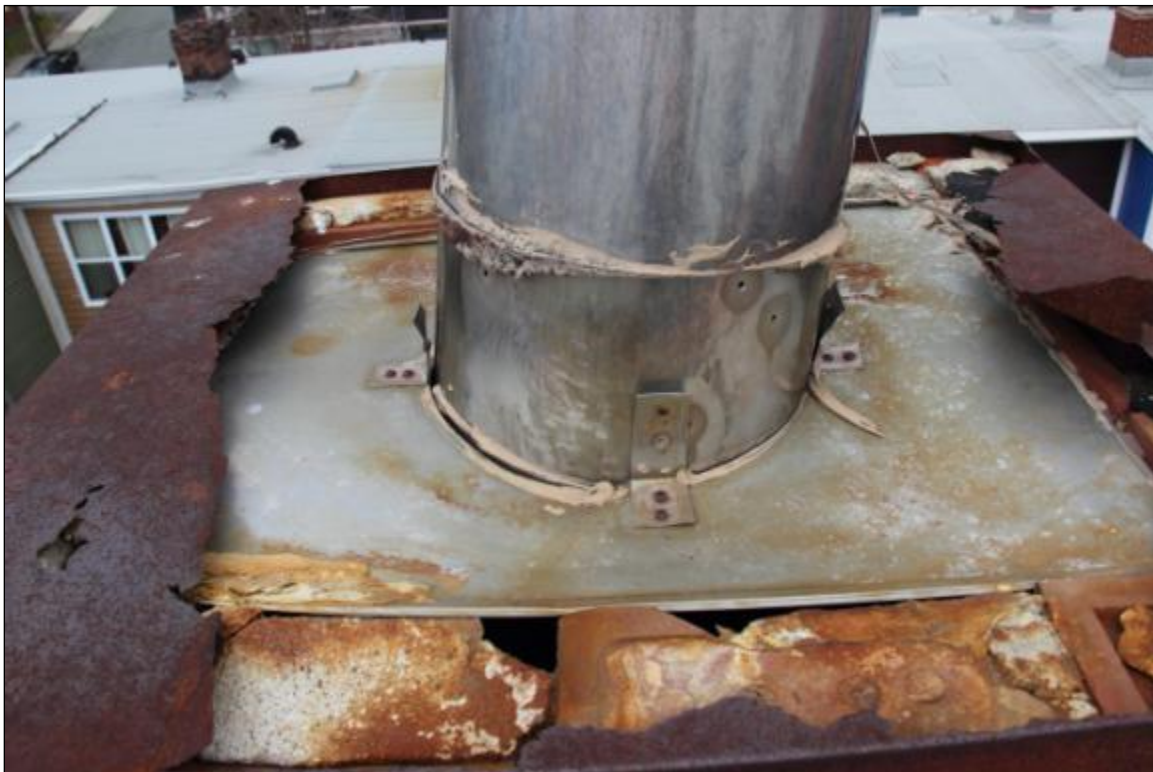
The brick chimney on the rear elevation has been fitted with a modern extraction flue which is in very poor condition. The mild steel sheet cover has completely failed and is allowing significant water ingress into the chimney flue. The fixings to the base of the modern stainless steel flue have also failed and as such the top section of flue is loose.

**Photo 12 - Top of chimney in very poor condition**

- Replace chimney cover to prevent further water ingress into the chimney flue.

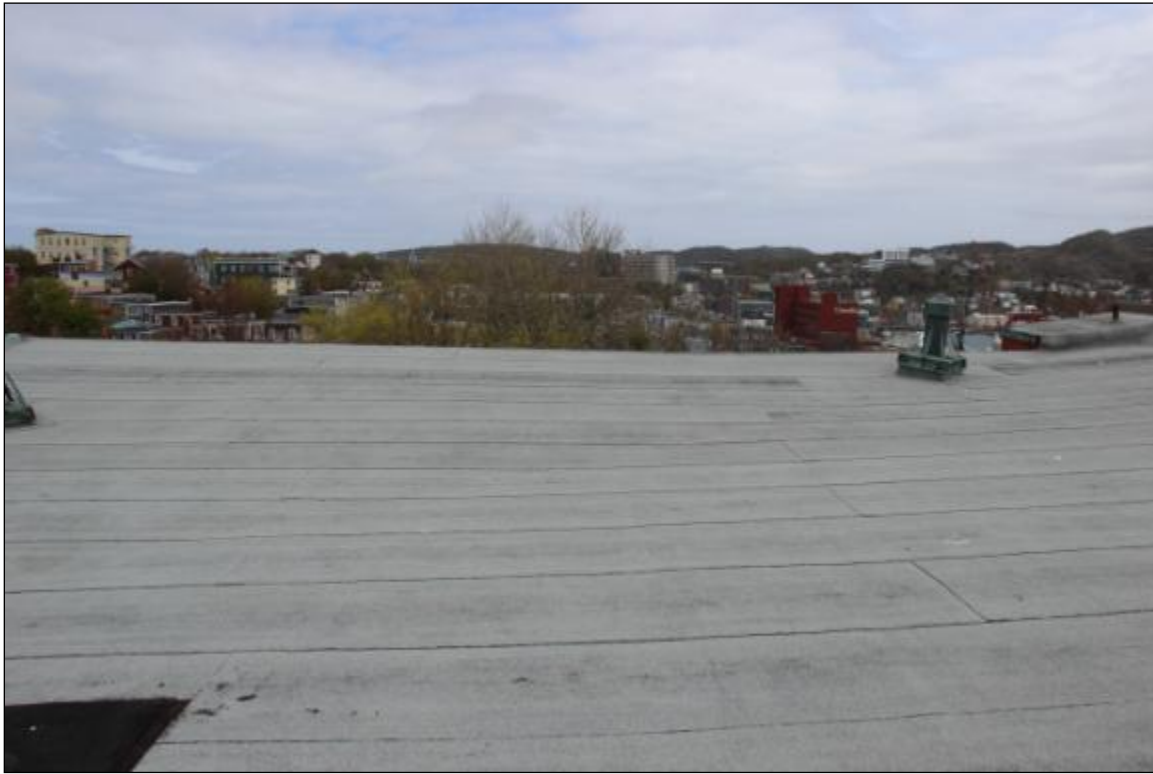
**Photo 13 - Modern felt roof covering in fair condition in need of localised repairs**

- Repair all damaged or missing felt slates to the 3 no. hipped roof sections to match existing.
- Repair the seal between the modern felt roof covering and the copper flashings around the perimeter of the roof to prevent further water ingress. The copper flashings should be installed to return back over the roof, fixed and sealed to prevent further standing water on the seam.

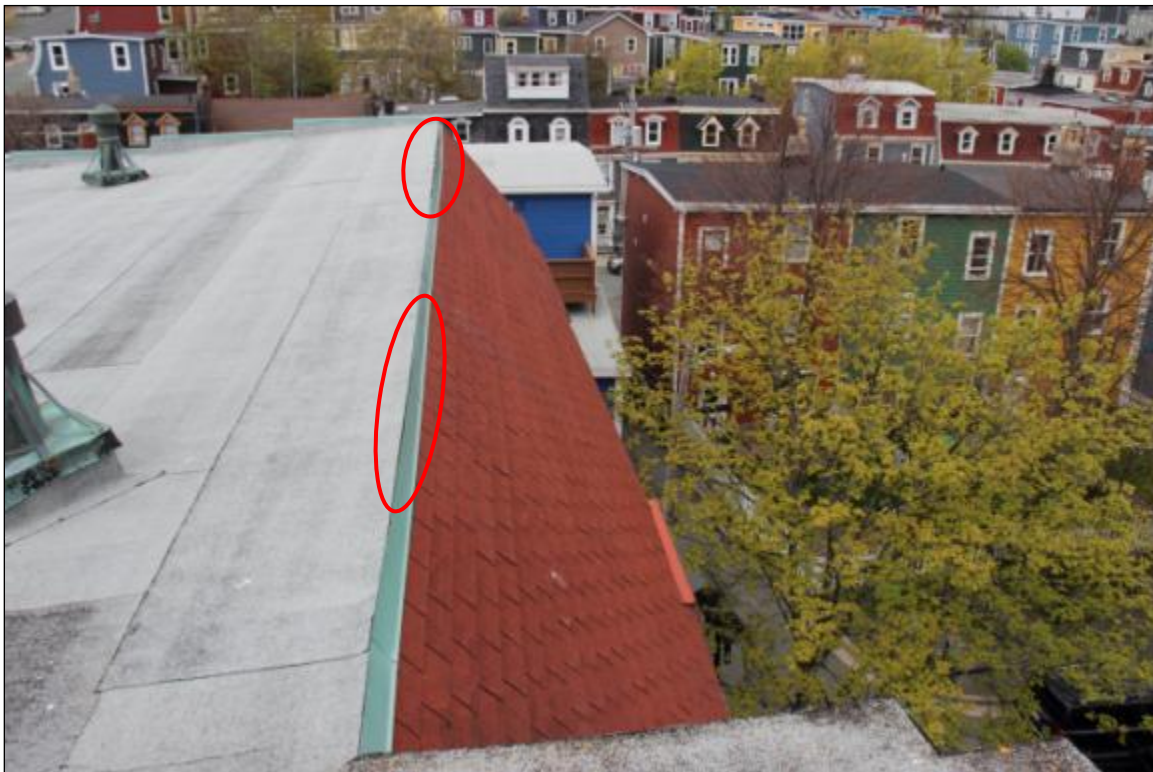
**Photo 14 - Failure of seal between roof cover and modern flashing**

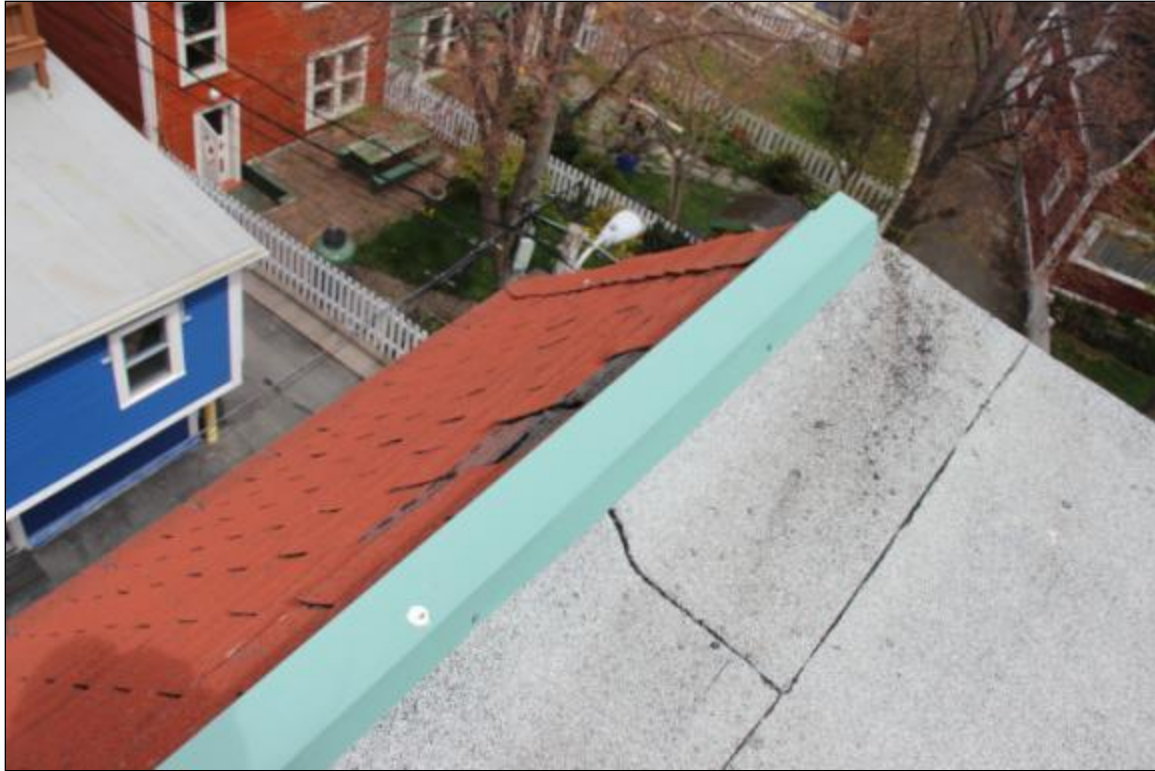
**Photo 15 - Damaged and missing felt slates to hipped roof section on rear elevation**

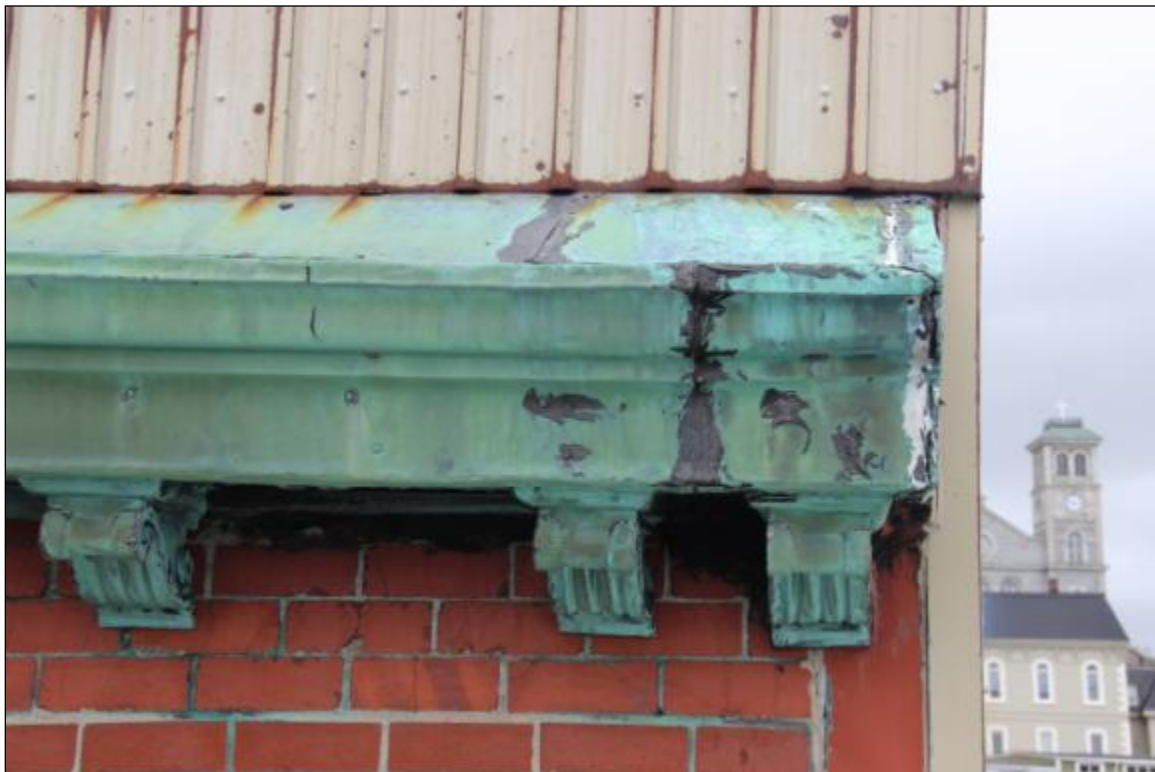
corrugated steel sheeting. This sheeting is rusting and causing staining of the copper elements below. During our inspection it was noted that the central tower roof is serviced by an internal cast iron downpipe which is an original feature. Access to the top of this roof area for inspection was not possible. This roof section is finished with a modern torch on felt and installed to allow rain water to run off both sides of the roof.

**Photo 16 - Staining of copper from rusting corrugated sheeting cover on central tower**

- Repair/replace the corrugated metal sheeting to the central tower to prevent further deterioration of the copper below. In order to stop the rusting of the sheeting the metal will need to be cleaned down, primed and painted to match existing or replaced.

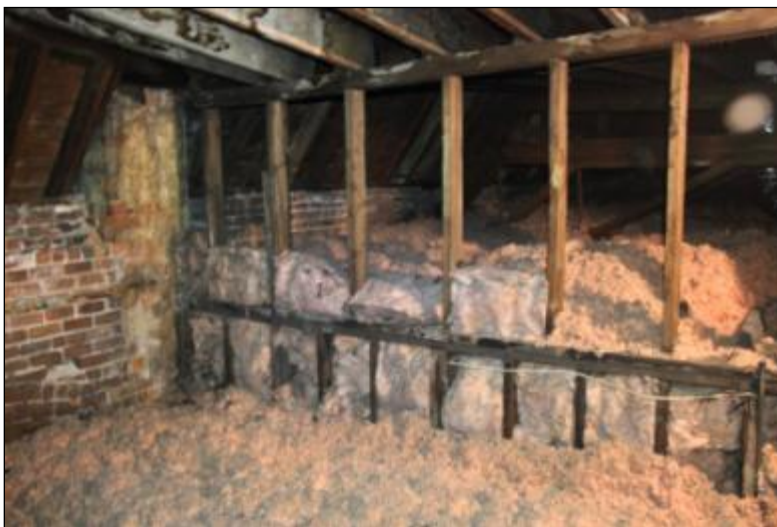
**Photo 17 - Evidence of water ingress on roof joists and timber frame**

- Roof repair works highlighted in section 4.4 above are required to prevent further water ingress into the attic space. Evidence of water ingress is noted in localised area particularly to the front elevation of the building.
- Immediate repair of the leaning section of wall to the rear elevation. Temporary propping should be considered until full scope of repairs can be carried out. It is also recommended to clear the external area below the leaning section of wall at ground level in case of collapse. Propane tanks are located directly below which are at risk of damage if a collapse occurs.

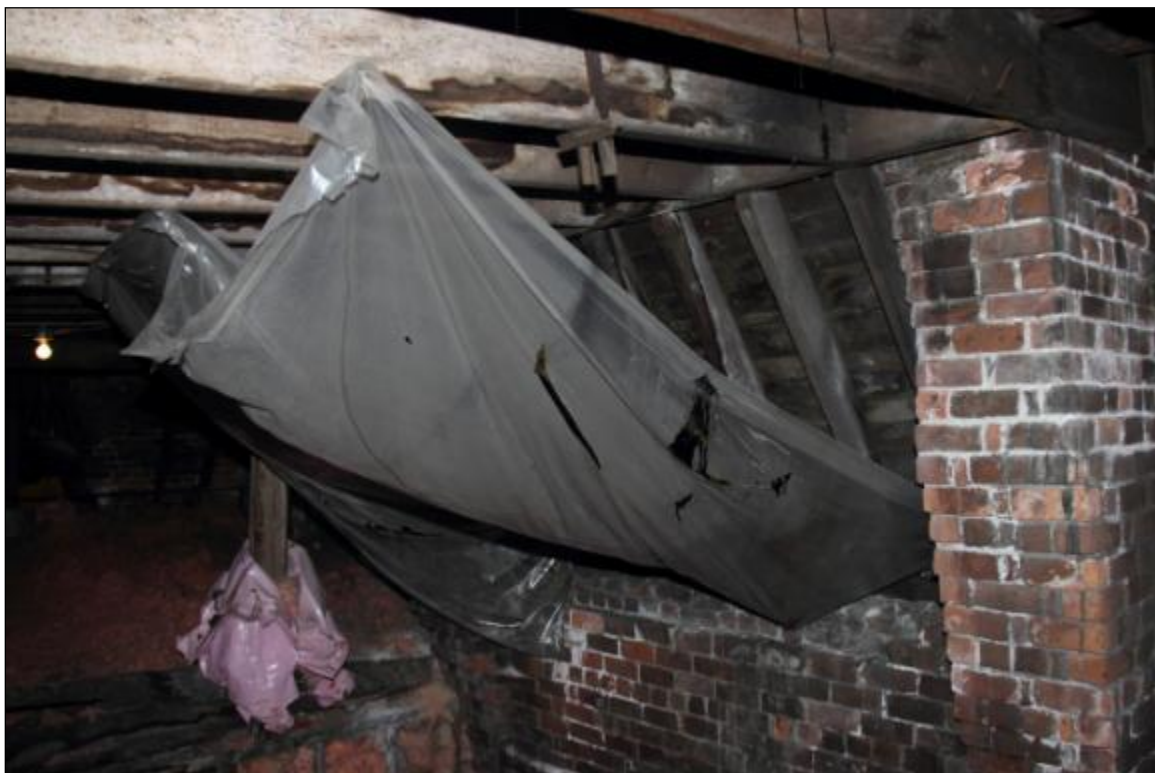
**Photo 20 – Significant active water ingress on hipped roof section of the Front Elevation**

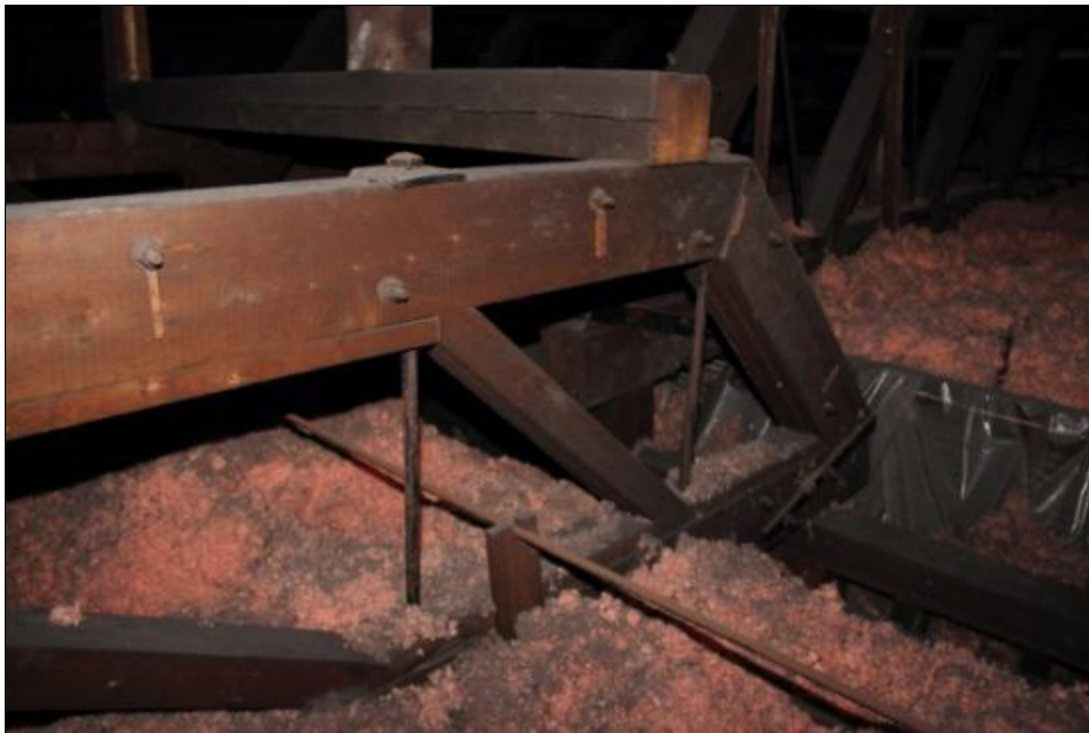
**Photo 21 - Main roof truss and internal timber frame in good condition**

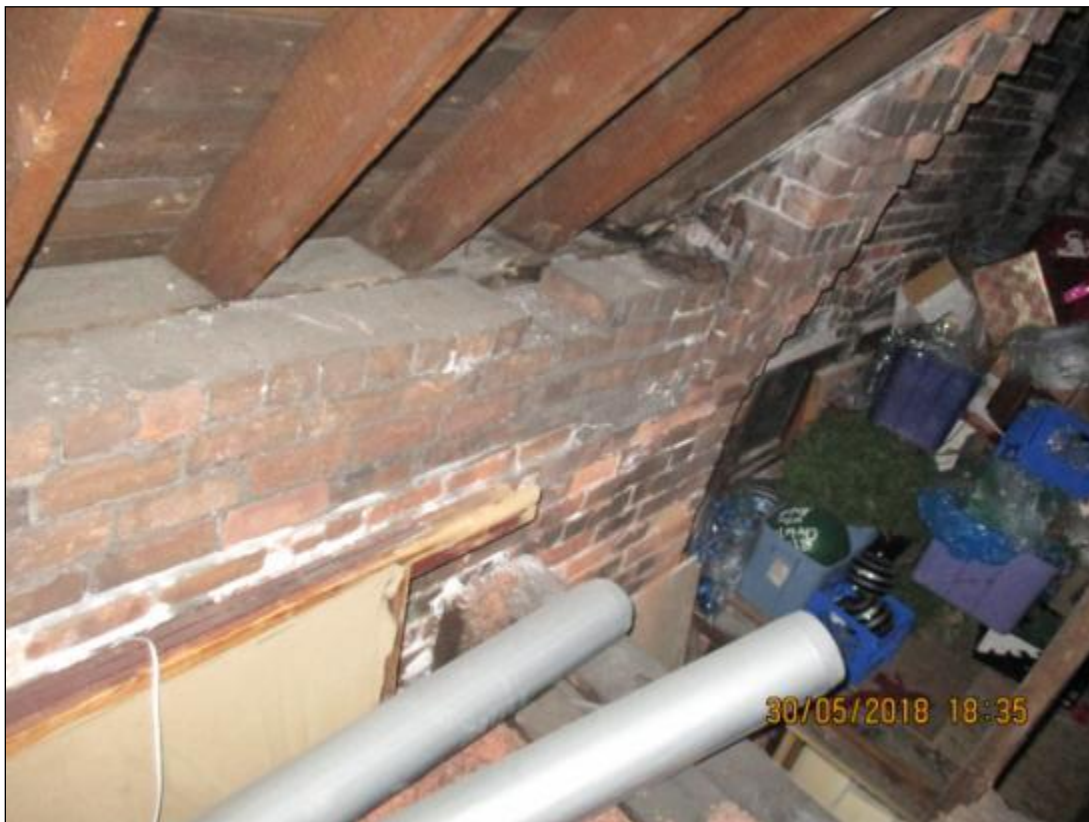
**Photo 22 - Water ingress at wall plate level of hipped roof section**

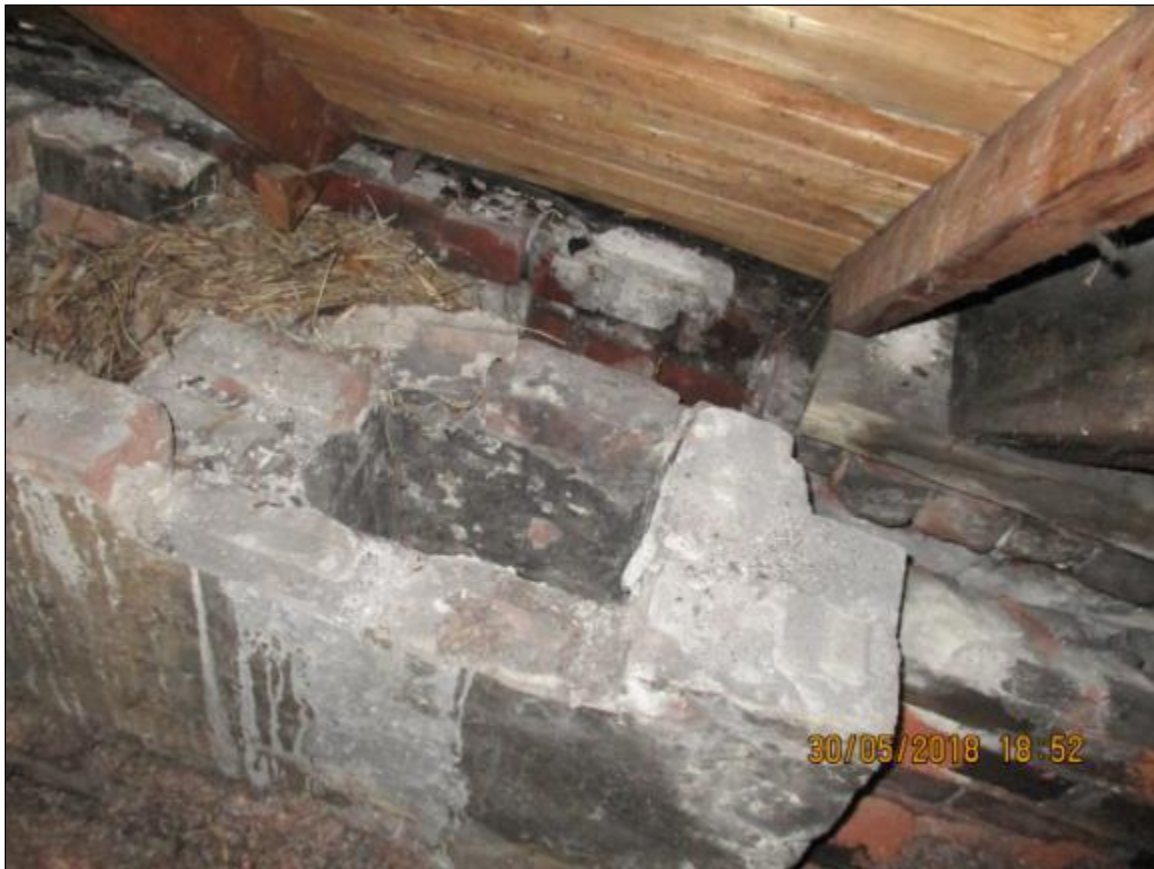
**Photo 23 - Leaning wall section of rear elevation. Note separation of the wall plate and previous modern repair works.**

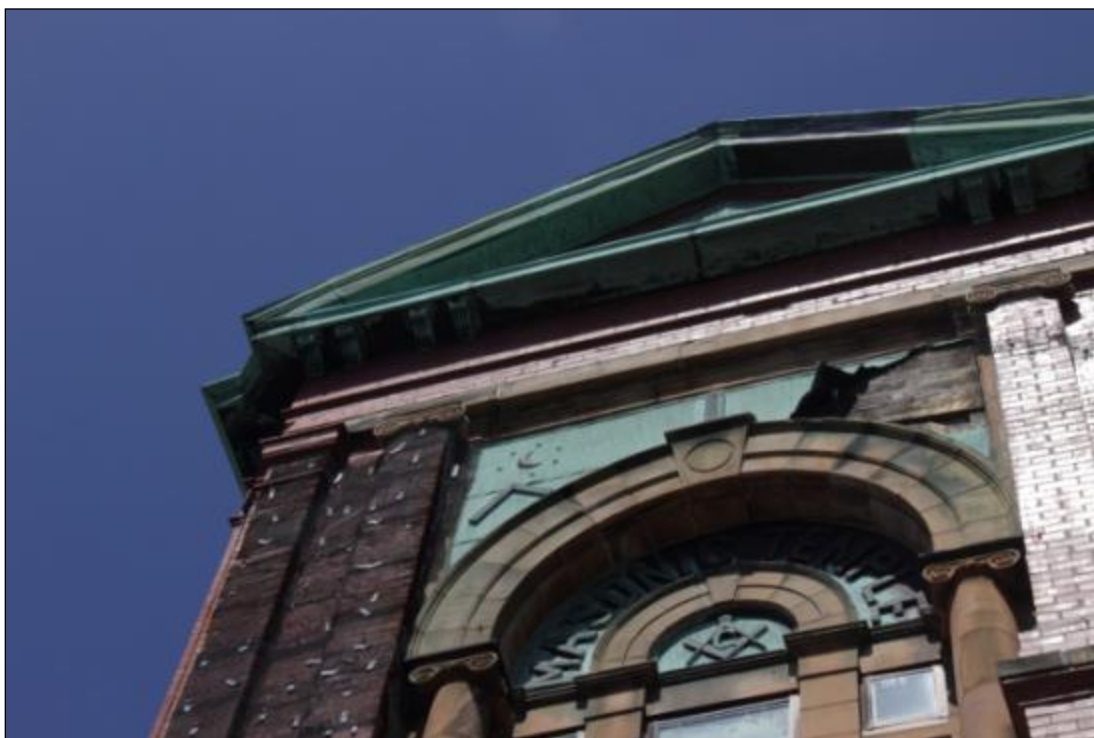
**Photo 24 - Damaged central decorative copper panel**

- Opening up works to be carried out including removal of sections of the copper fascia and soffits to assess condition of timber underneath. Inspection of timber formwork behind the 3 no. decorative panels.

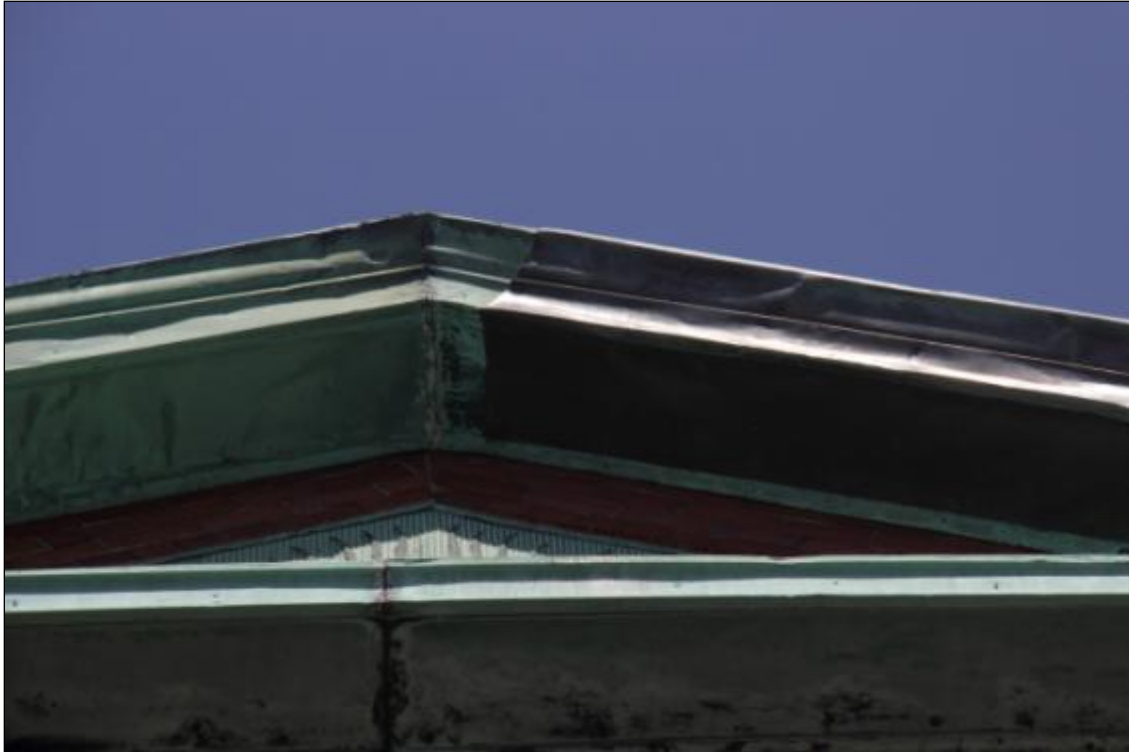
**Photo 25 - Modern patch repair to top fascia and soffit of central tower**

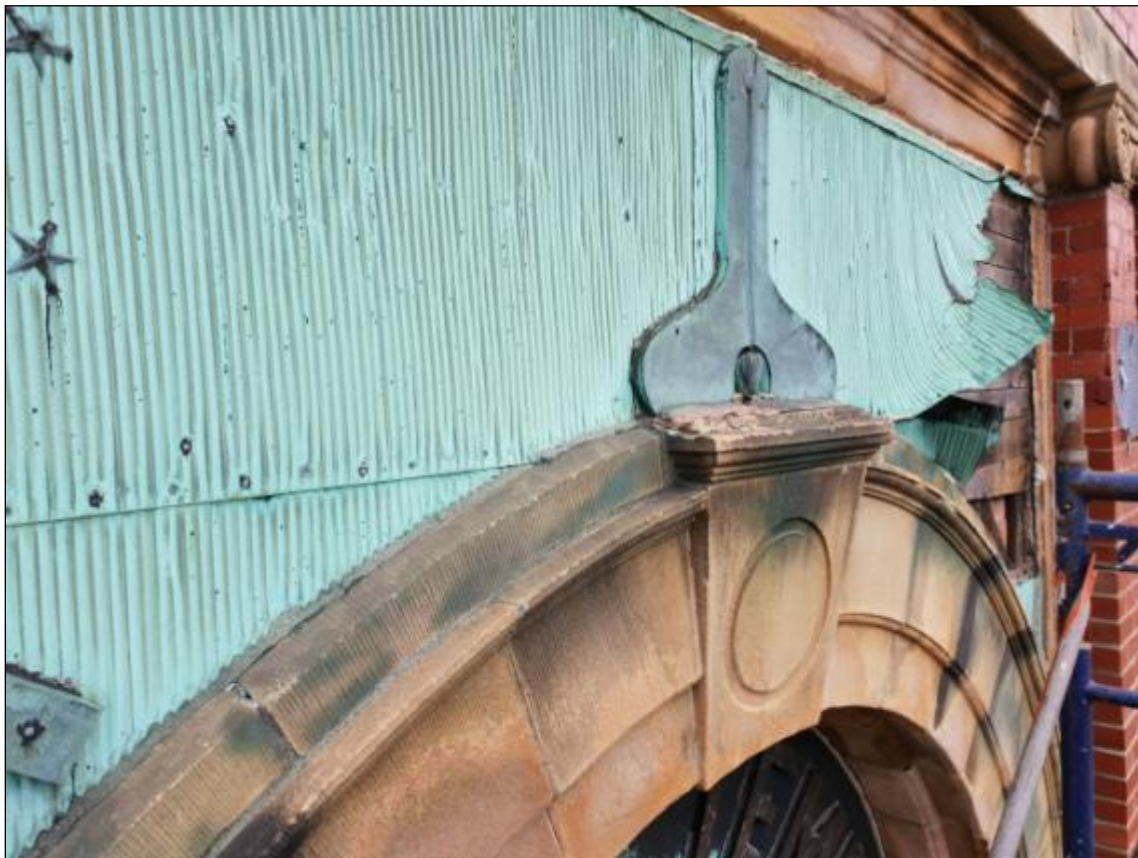
**Photo 26 - Modern mastic repairs to joints of copper work**

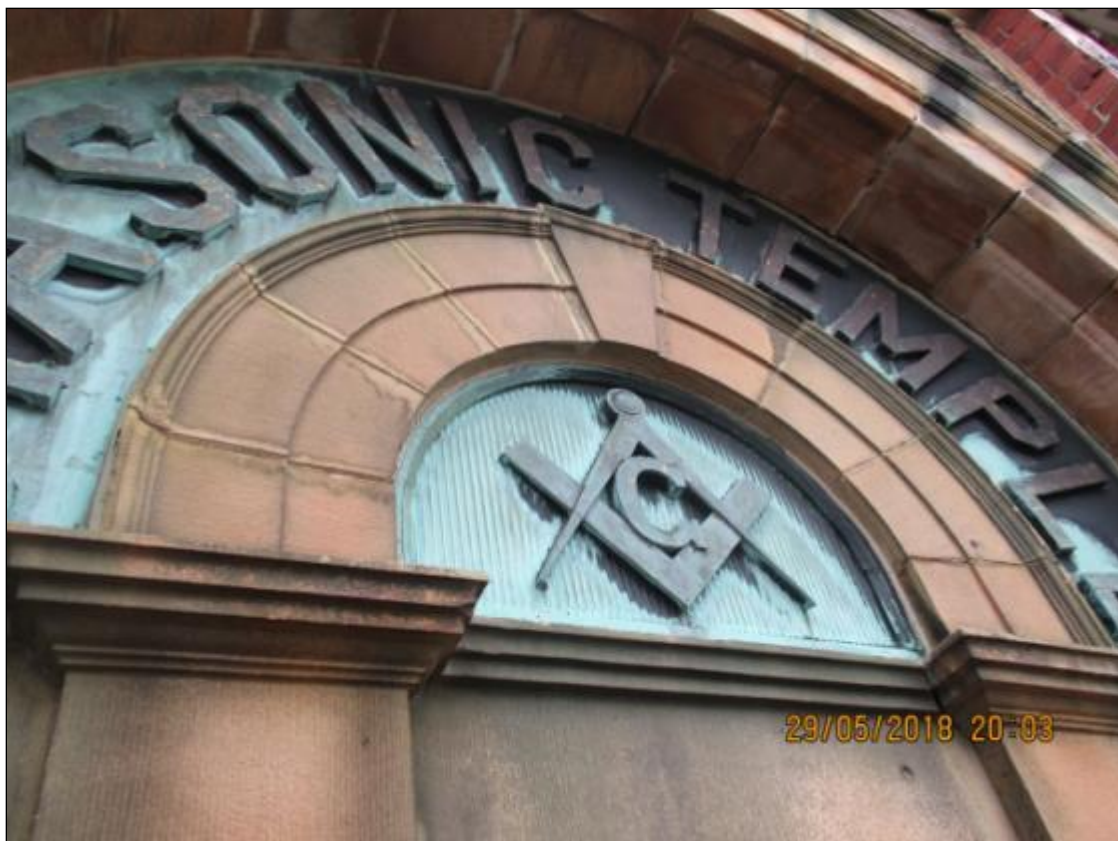
**Photo 27 - Lower decorative panels in need of remedial works**
